Design and optimization of a semi-trailer extendable RUPD according to UNECE R58

Extensive tests were carried out on the rear protection equipment of a tipper-type silobus semi-trailer. This study includes the design and optimization process of an extensible rear underrun protective device for O4 category semi-trailers. Material selection and structural design features were evaluated within the framework of harmonization with regulation 58 of the European Commission. Design verification was done in 4 stages. Two of them were carried out by computer simulation and the other two were carried out as physical tests. The aim of the study is to increase the safety of the vehicle and other road users in accidents resulting in the under-vehicle entry. Ensuring a rear underrun protective device design that meets the test force requirements found in UNECE R58 is a key performance indicator in research. Also, it is aimed at reducing carbon emissions in vehicles where the rear underrun protective device will be used by providing the regulation conditions at a minimum level, simplifying the rear underrun protective device design, and simplifying the design. The output of the optimization proce

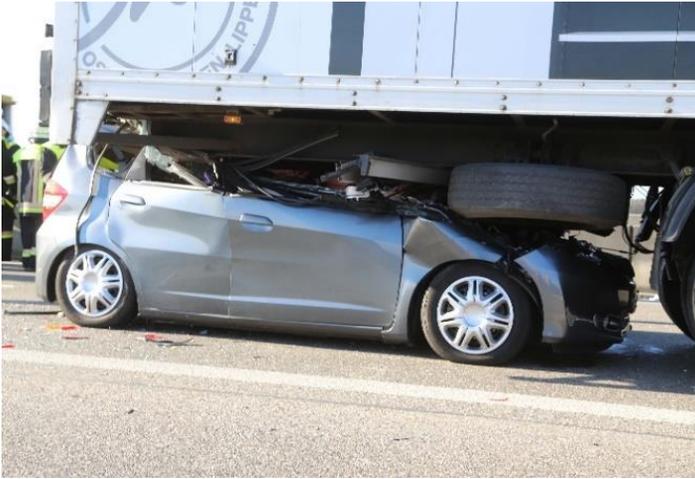
Figure 1. Typical rear underrun collision

dents result in death. In this type of accident, the longitudinal structural members of passenger cars slide under the truck. Rear-end collisions are vital to injuries sustained by passenger car occupants, as the hood and A-pillars collide with the rear structure of the heavy-duty vehicle. In Figure 1, photograph is given as examples of accidents that result in getting under a vehicle from behind.

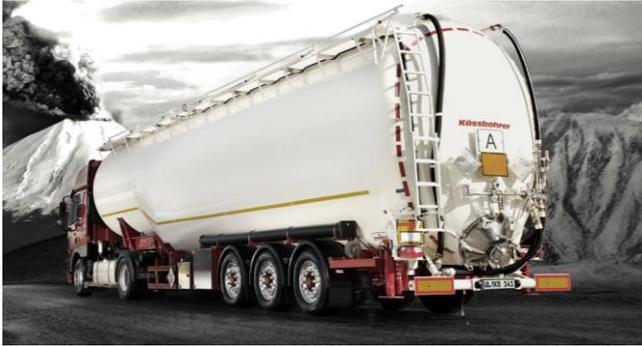
Figure 4. Vehicle type (Kässbohrer SSK)

The general representative photograph of the vehicle type and the general RUPD construction of this vehicle type is shown in Figure 4. and Figure 5. The base construction material of the RUPD structure is reinforced steel.

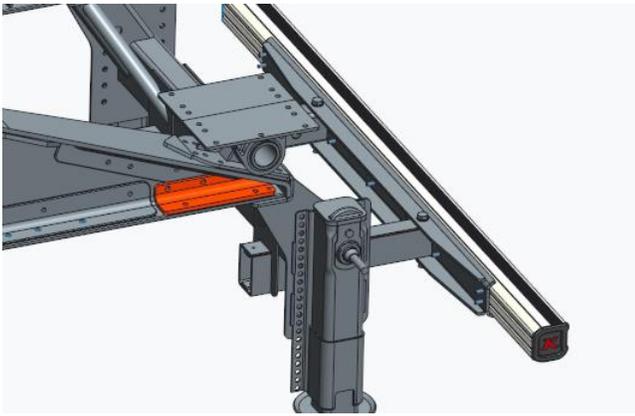
Figure 7. Design revision: Additional L support bracket

According to the analysis data from the ANSYS, high stress occurs at the point where the RUPD is attached to the chassis. It has been observed that high stresses occur at the point where the RUPD is attached to the chassis, especially in the scenario where a force of 18 kN is applied. This has been found to have the potential to cause damage to the chassis. In order to prevent this situation and to prevent the chassis from being damaged during the actual test, an auxiliary element is connected to the high-stress area of the chassis. Figure 8 shows the result of the finite element analysis made after the support element and the support element were added to the high-stress section of the chassis. As seen in Figure 8, the rigidity of the chassis has been increased thanks to the added L support bracket (indicated as orange below in Figure 7.).

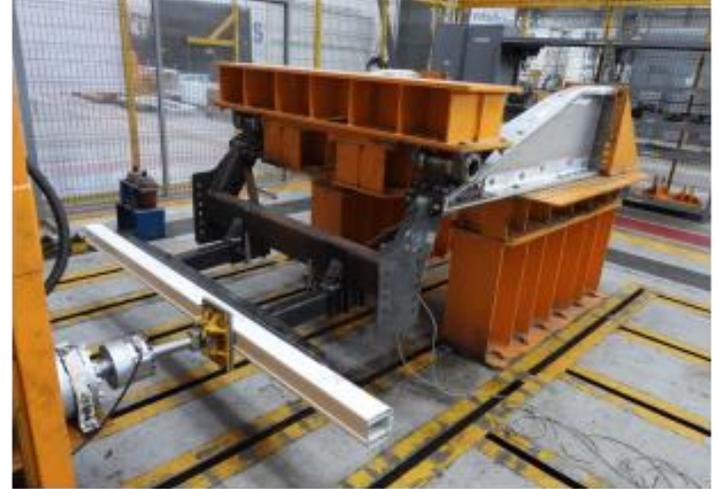
Figure 9. Rigit test bench

The RUPD is fixed to the rigid bench as shown in Figure 9. Test details, forces and application points are described below. Figure 10. shows the force points to be applied on the RUPD. The points where the forces will be applied are determined as defined in the regulation.

The rigid wall, on which there is a cylinder that will apply the test force, is fixed to the ground with the help of shoes in the area where the test will be applied on the vehicle. Force was applied to the points determined respectively. Deformation control was carried out after each point where force was applied.

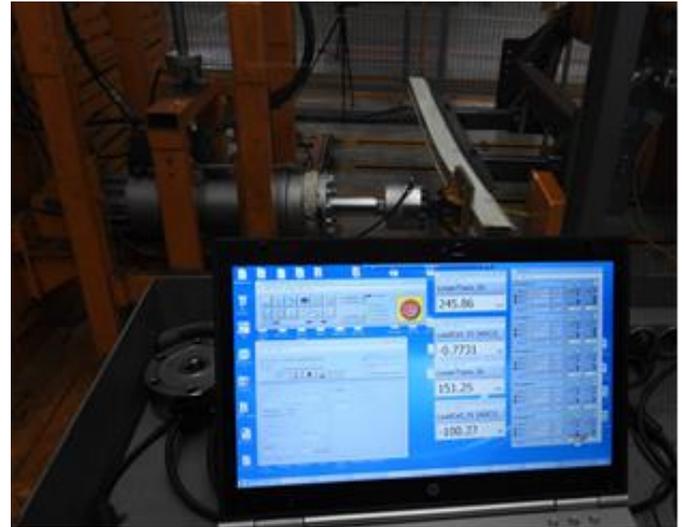
Figure 12. Deflection on P1 RIGHT test case in first test

The first test started with the application of force to the P1R point of the RUPD. According to the legislation, the test can be started from any desired point. The reason for starting from this point is that the P1R point, which is far from the force arm, is considered as a worst condition. In the first test, RUPD exceeded the displacement

value defined in R58 and the test failed. Testing was not continued as the first P1R scenario failed. The next step was a design improvement. The picture of the P1R scenario of the first test is given in Figure 12. below.

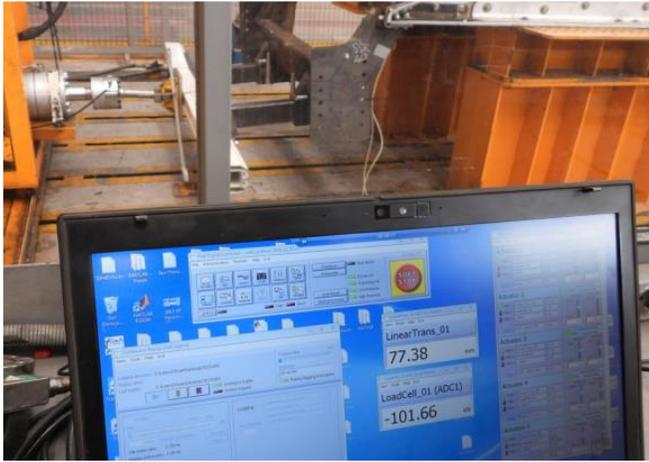
Figure 19. Photo of deflection on P3 MIDDLE test case in second test

At this point, a maximum force of 103.35 kN was applied and 25.44 mm elastic deformation and 6.12 mm plastic deformation were detected horizontally. 10 mm elastic deformation were detected vertically.
